Phase One Environmental Site Assessment

Part of Lot 35, Concession 6, Community of Udora, Township of Uxbridge, Ontario

2695867 Ontario Inc.

October 24, 2022

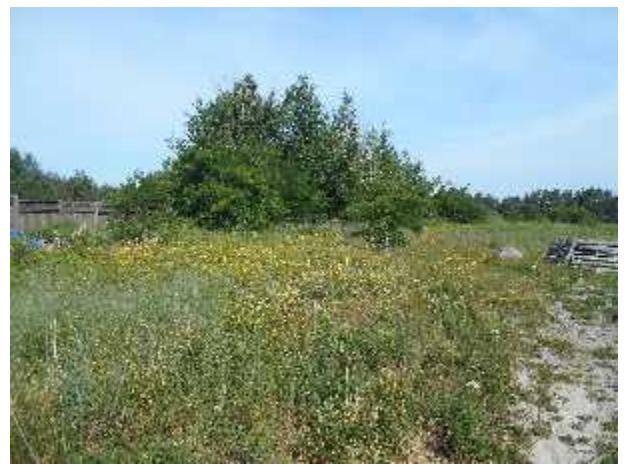
Photograph 1. View looking north at debris from the southwest boundary of the Phase One Property.

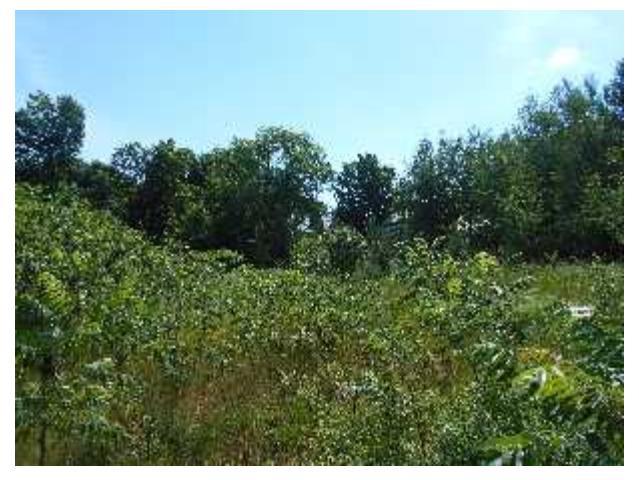
Photograph 2. View looking east at the potential salvage yard area.

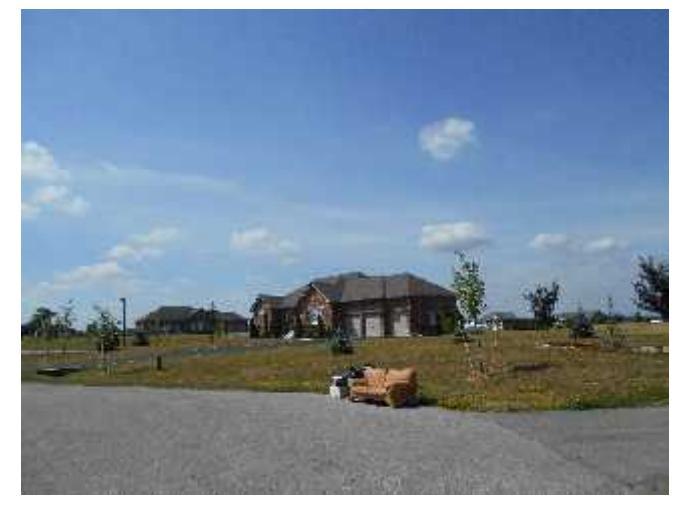
Photograph 8. View of the neighbouring property to the southwest of the Phase One Property. A propane tank is visible to the north of the residence.

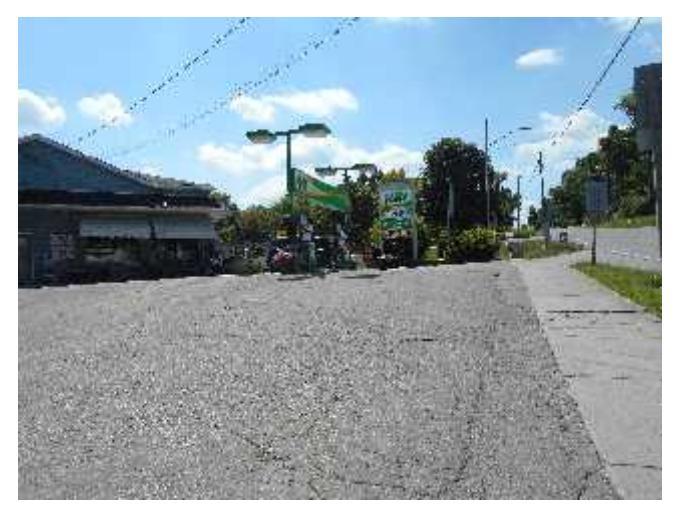
Photograph 30. View of the gas station to the northeast of the Phase One Property.

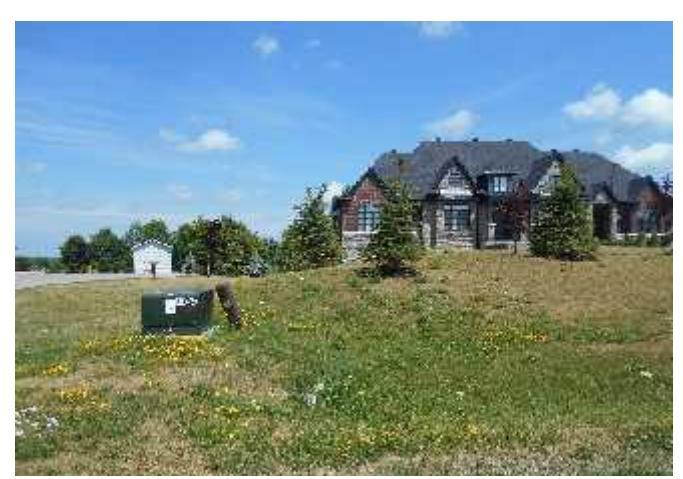
Photograph 21. View of a transformer box along Birdie Smith Court.

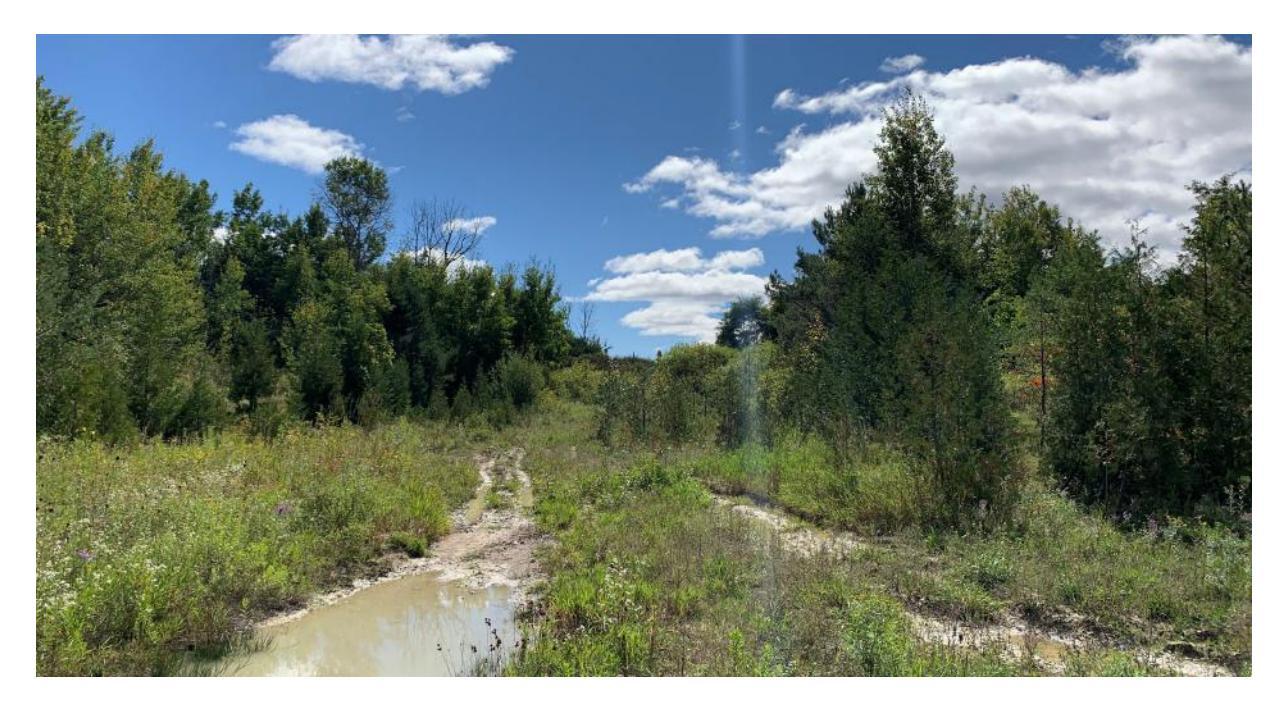
Photo 4 View of the central portion of Site, facing south

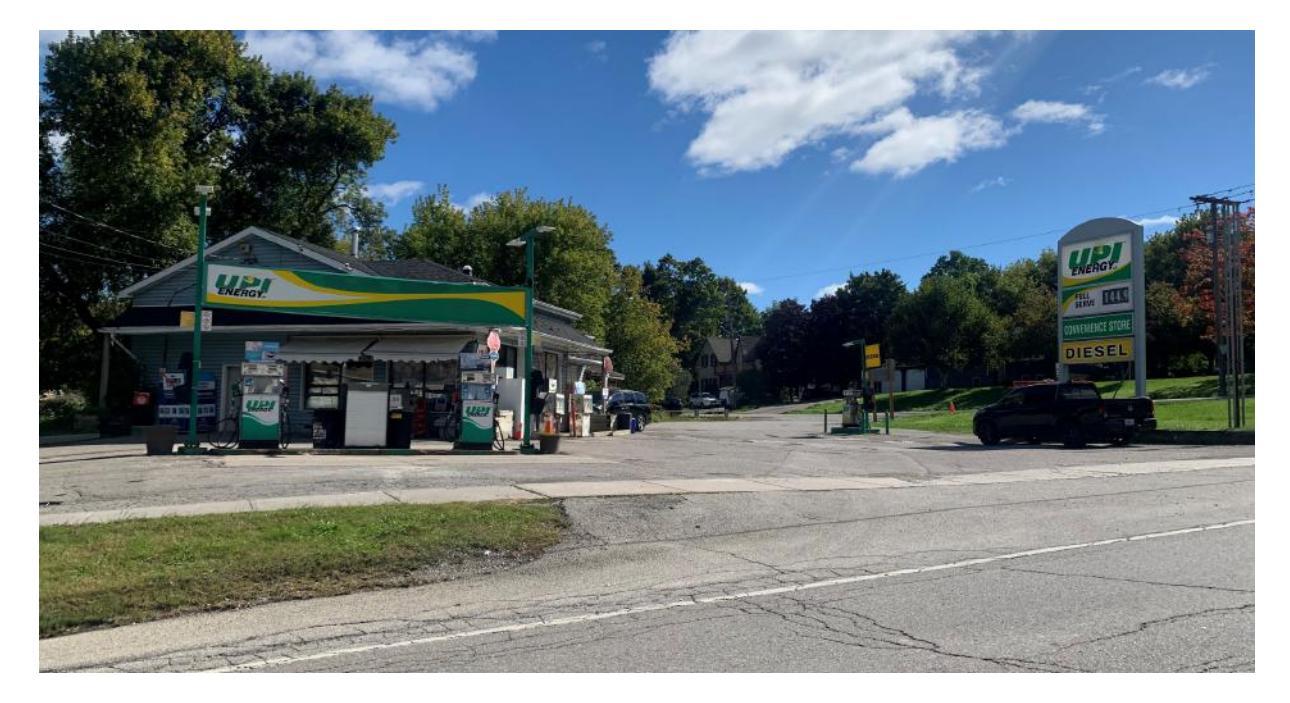
Photo 6 View of UPI Energy, located approximately 90 m northeast of Site at 5 Victoria Road, facing northeast
