Phase One Environmental Site Assessment

Existing Agricultural Property 3469 Concession Road 1 Township of Uxbridge, Ontario

Report for Grainboys Holdings Inc.

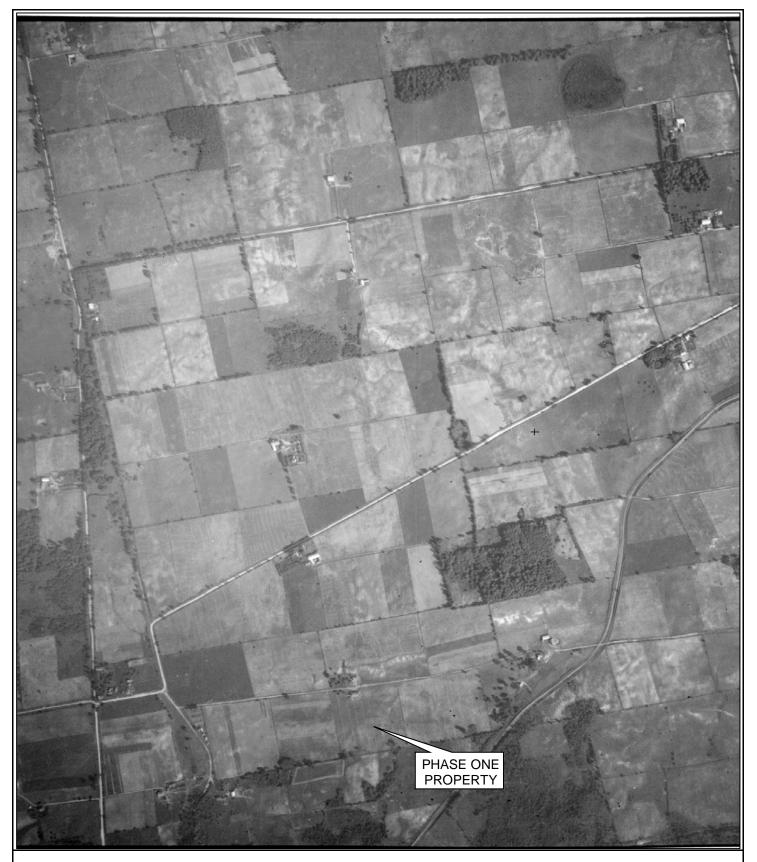
# **AERIAL PHOTOGRAPHY - 1927**

The image from 1927 shows the Property as largely agricultural. A driveway/roadway traverses the central portion of the Property. A structure is present to the south of this roadway. A rail line is observed within the Phase One Study Area at this time. The surrounding area largely agricultural.

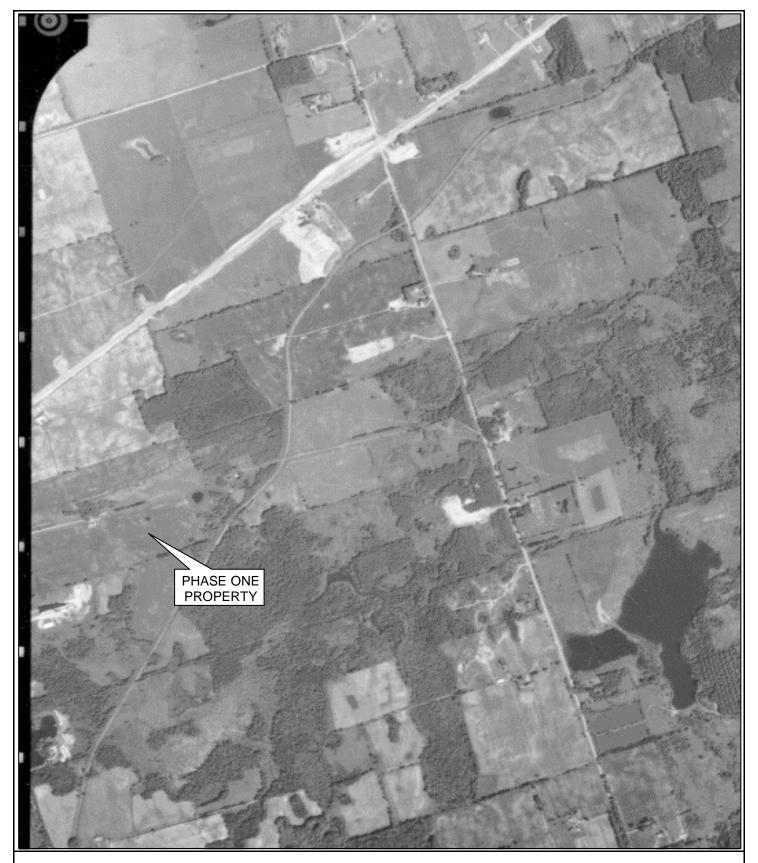
# **AERIAL PHOTOGRAPHY - 1985**

The 1985 image shows the construction of the adjacent rural industrial facility. An area of ponded water is present on the eastern portion of the Property. Additional tree cover is observed on adjacent lands to the east.

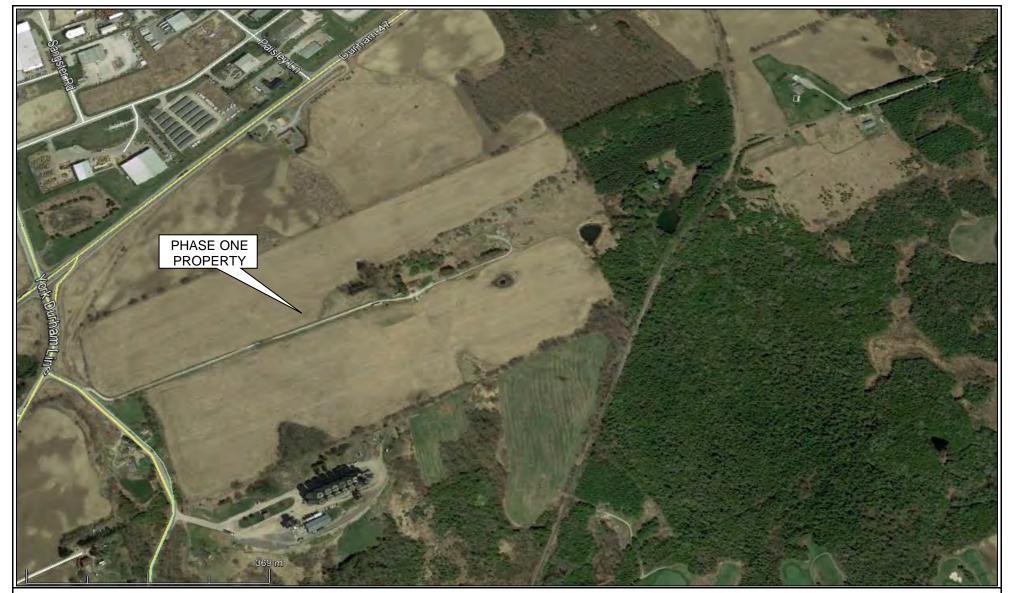
The 2005 Google Earth image shows the removal of the previous structure on the Property. A new residence has been constructed by this time. The 2018 image shows little change, and shows the area as generally observed during the site reconnaissance. An extension of the driveway to the north is observed. This area has been used for depositing vacuum truck waste. The importation of fill of unknown quality is a PCA warranting further investigation. The adjacent rail line should also be further investigated. APECs are identified.

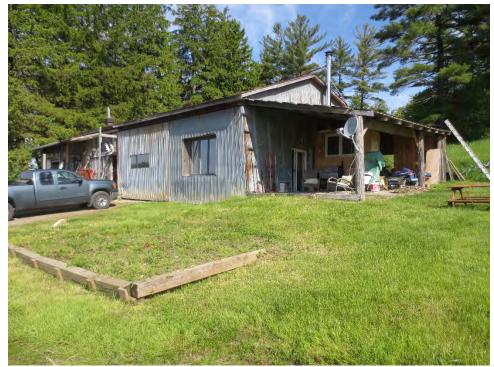
Photo 5 – View of dwelling near central area of site looking towards the northwest.

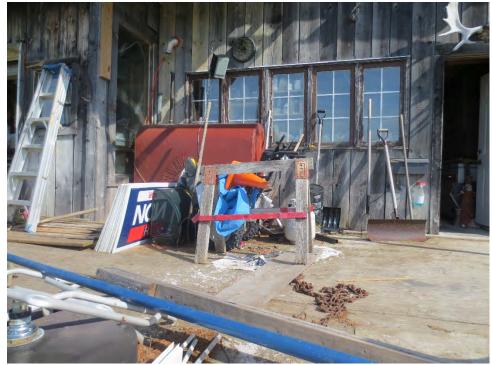
Photo 7 – View of adjoining workshop looking towards the north.

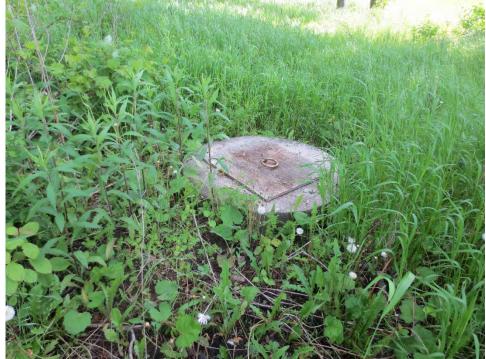
Photo 9 – On-site dug well servicing dwelling, located west of dwelling/workshop (looking towards the northeast).

The area is privately serviced for water and septic. GHD observed one (1) drinking water well during the site reconnaissance. Based on well records reviewed from the ERIS report, subsurface materials in the area typically consist of sandy and clayey materials. If any water wells or monitoring wells are required to be decommissioned, they should be abandoned in accordance with Ontario Regulation 903.

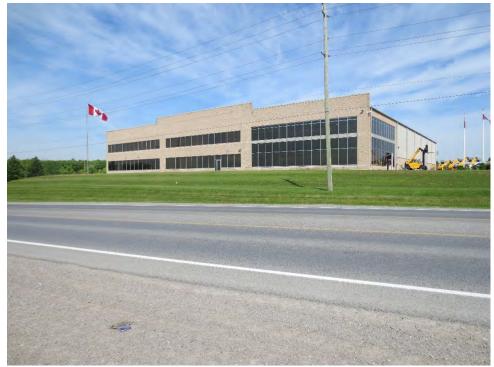
Photo 11 – Neighbouring land further to the north: works department (looking northwest across Regional Road 47).

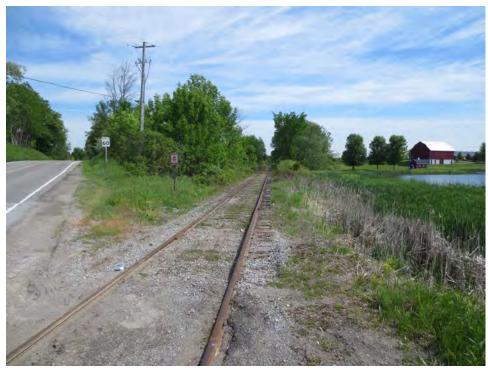
Photo 14 – Neighbouring land further to the south: railway line (looking northeast from Concession Road 1).
