Functional Servicing and Stormwater Management Report

Wooden Sticks Golf Course

Wooden Sticks Golf Inc.

November 2022

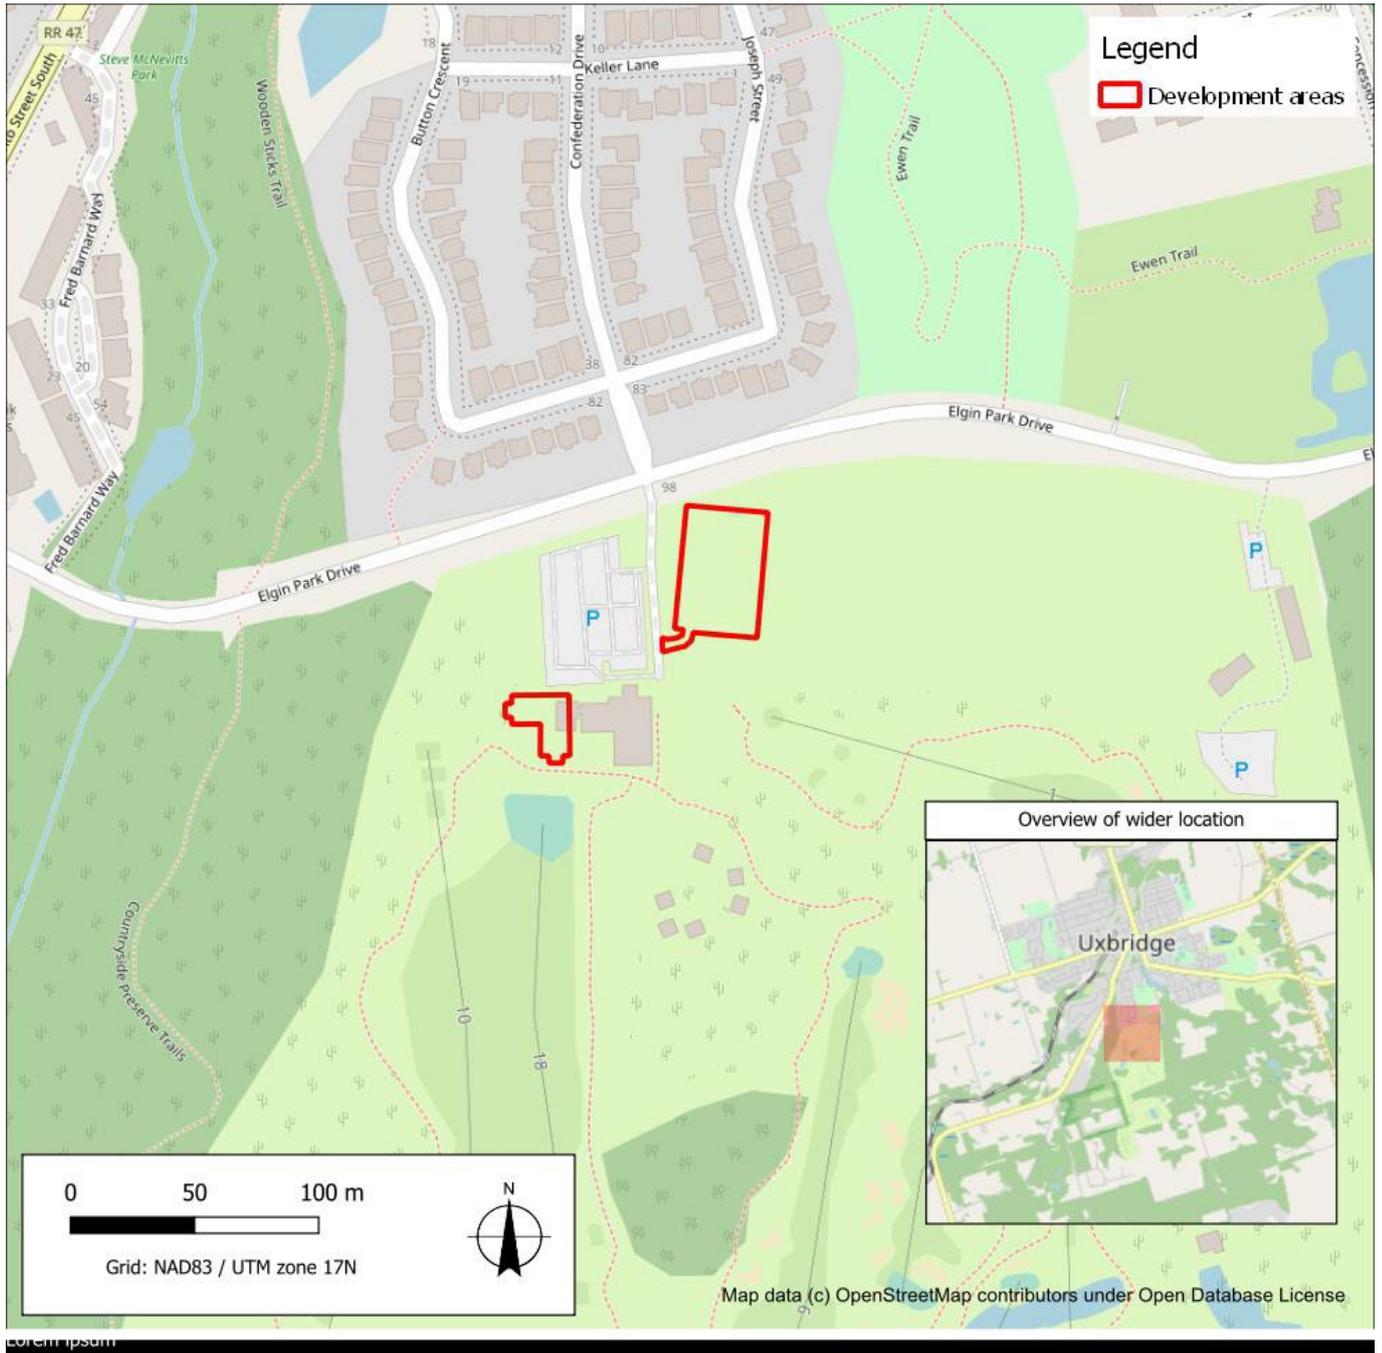
Figure 1 Site Location Plan showing two areas of development on wider property.

The property is bound by Elgin Park Drive to the north, land used by the golf course is to the east and south, and to the west is a wooded area, and west of this woodland is a new area of development comprising of townhouses. **Figure 1** below shows an overview of the development location.

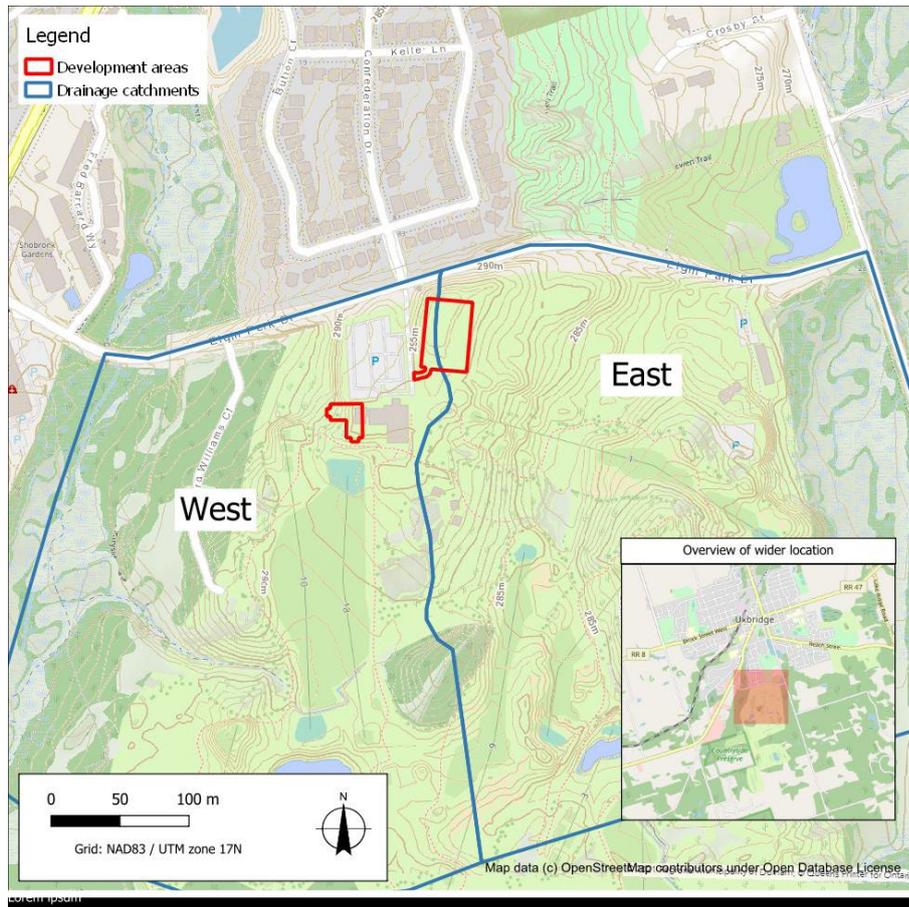
Figure 4 Widescale Catchment Areas - Watersheds

In order to understand the drainage catchment of the property and areas to be developed freely available large scale elevation data was reviewed. This identified that the property occupies the crest of a hill and the two areas to be developed drain ultimately in separate directions. The approximate catchment areas are shown below in **Figure 6**.

In Section 4.1 a detailed appraisal of the runoff route of the parking lot existing land is carried out using the site-specific topographic survey. It is concluded whilst it is located on the watershed boundary the runoff ultimately all flows east.

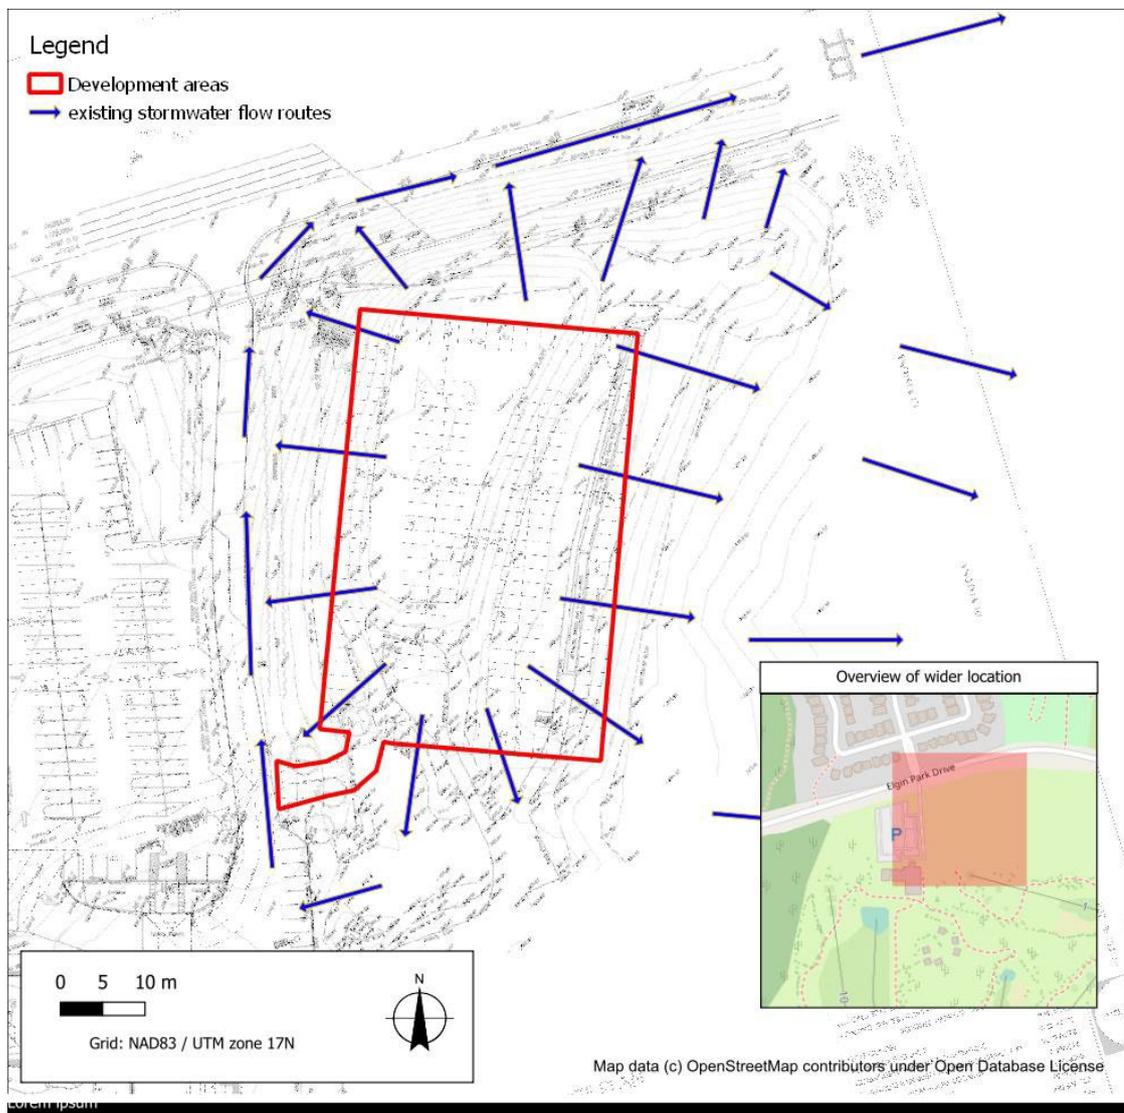
Figure 5 Existing stormwater runoff routes from development area from the north and west slopes of the parking lot area to catch basin on Elgin Park Drive.

The remainder of the runoff from this development area will drain east across open green space associated with the golf course property, before eventually reaching the watercourse that flows under Concession Road 7. This flow mechanism is understood to be via overland flow and is via a single conveyance feature such as ditch or drain.

Given the above review of elevations of both the proposed parking lot area and wider context, it is concluded that all runoff from the area of new parking lot currently drains east, away from the site. Post development, this runoff direction should be retained to help maintain water balance and flow patterns.

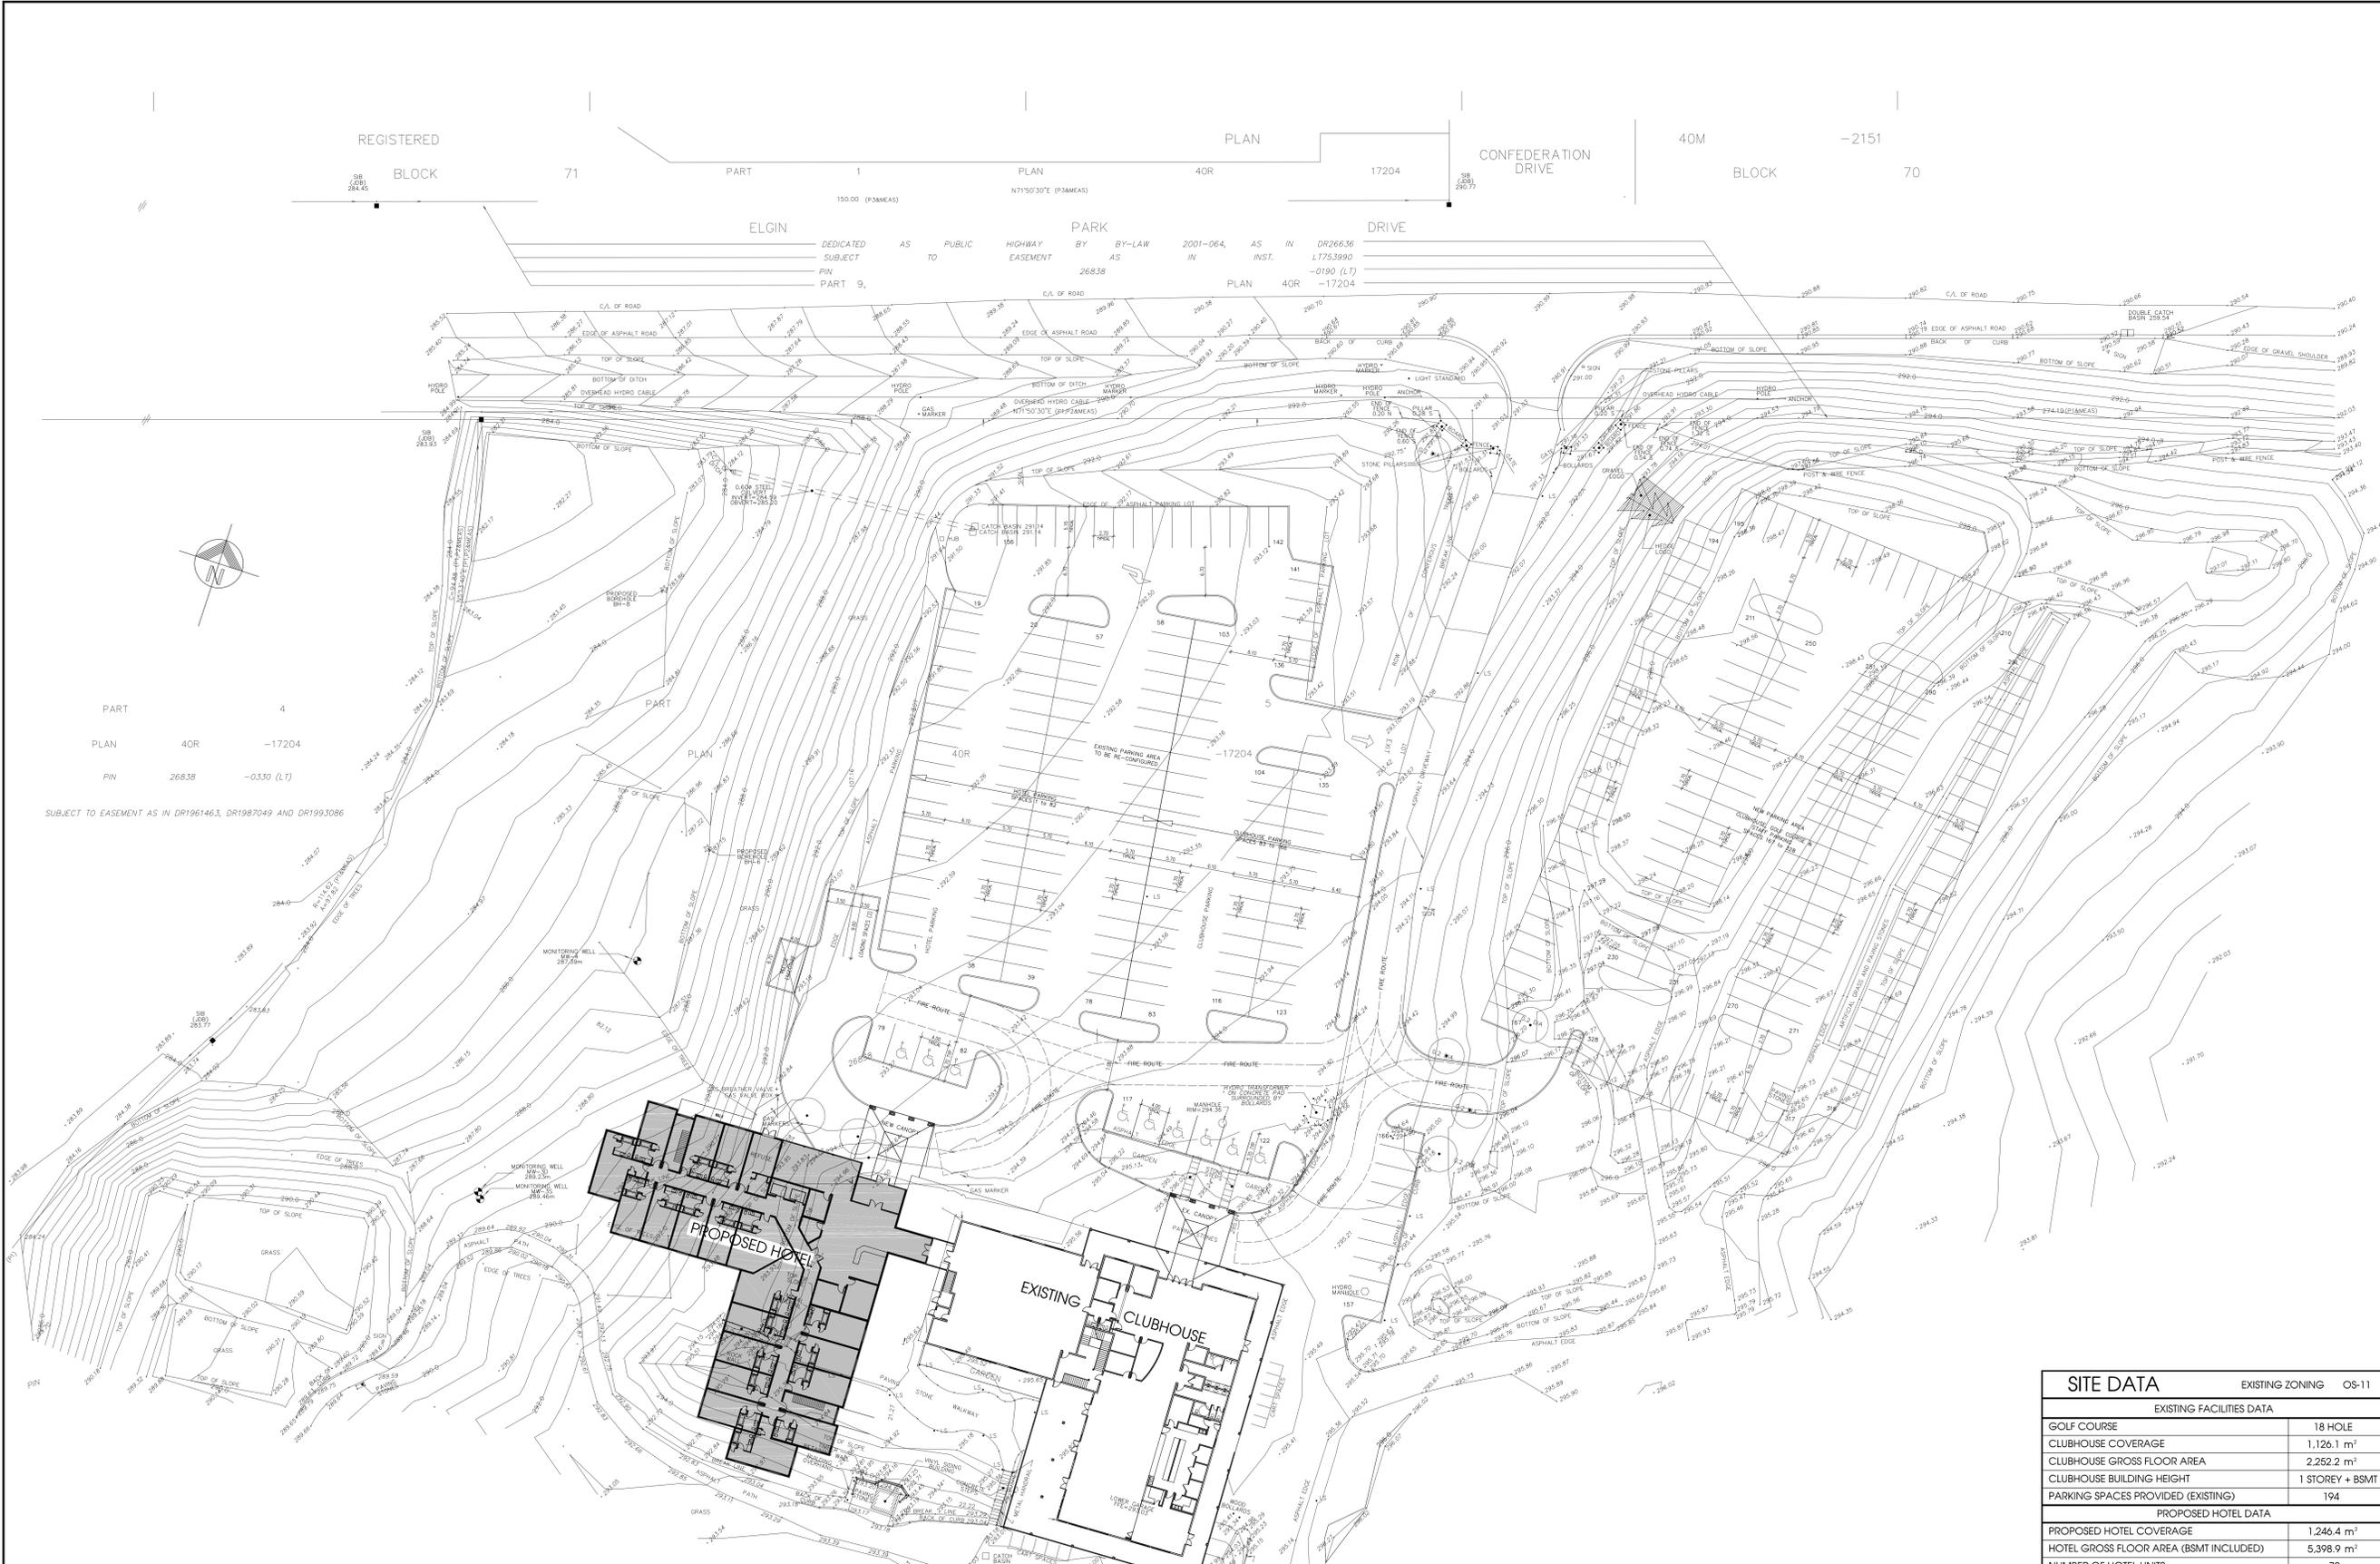
A01

SITE PLAN
 SCALE - 1 : 300

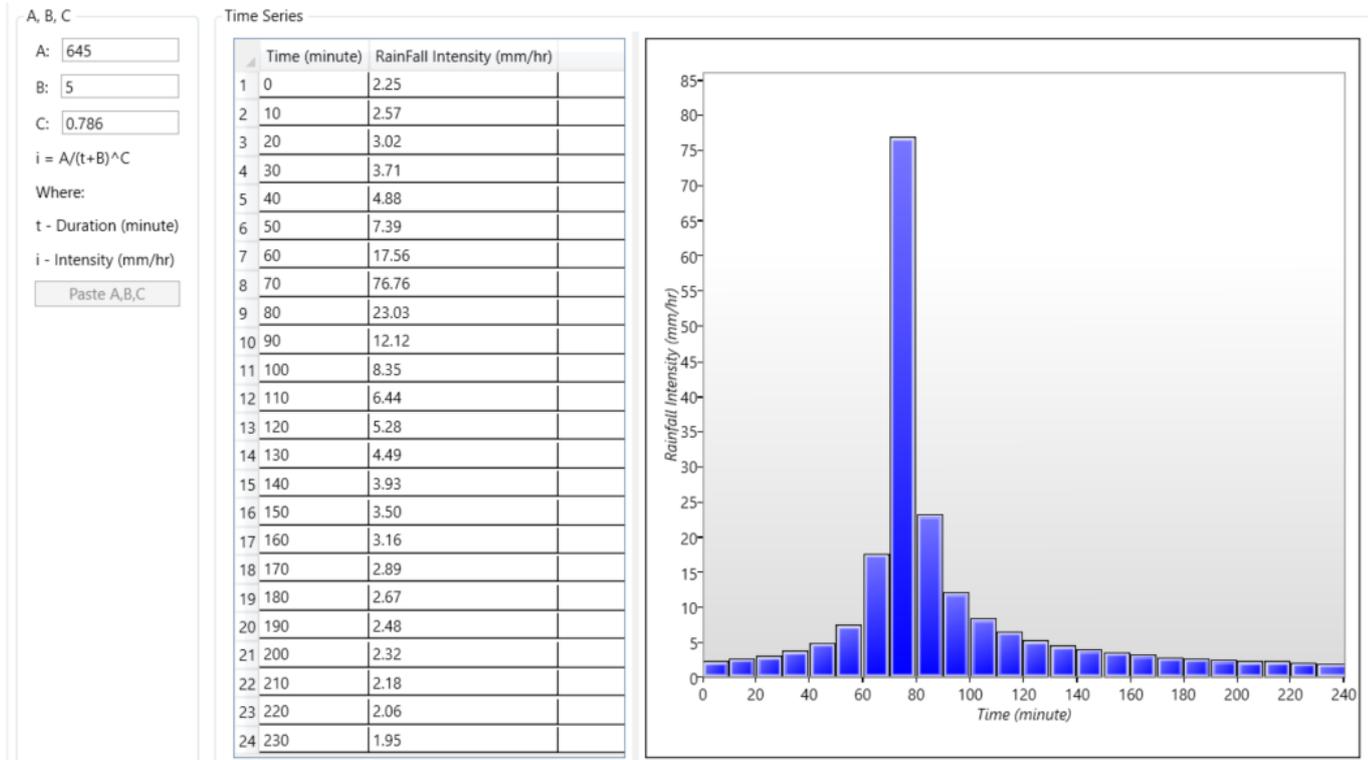
Figure C-1: 1 in 2 year hyetograph exported from Visual Otthymo

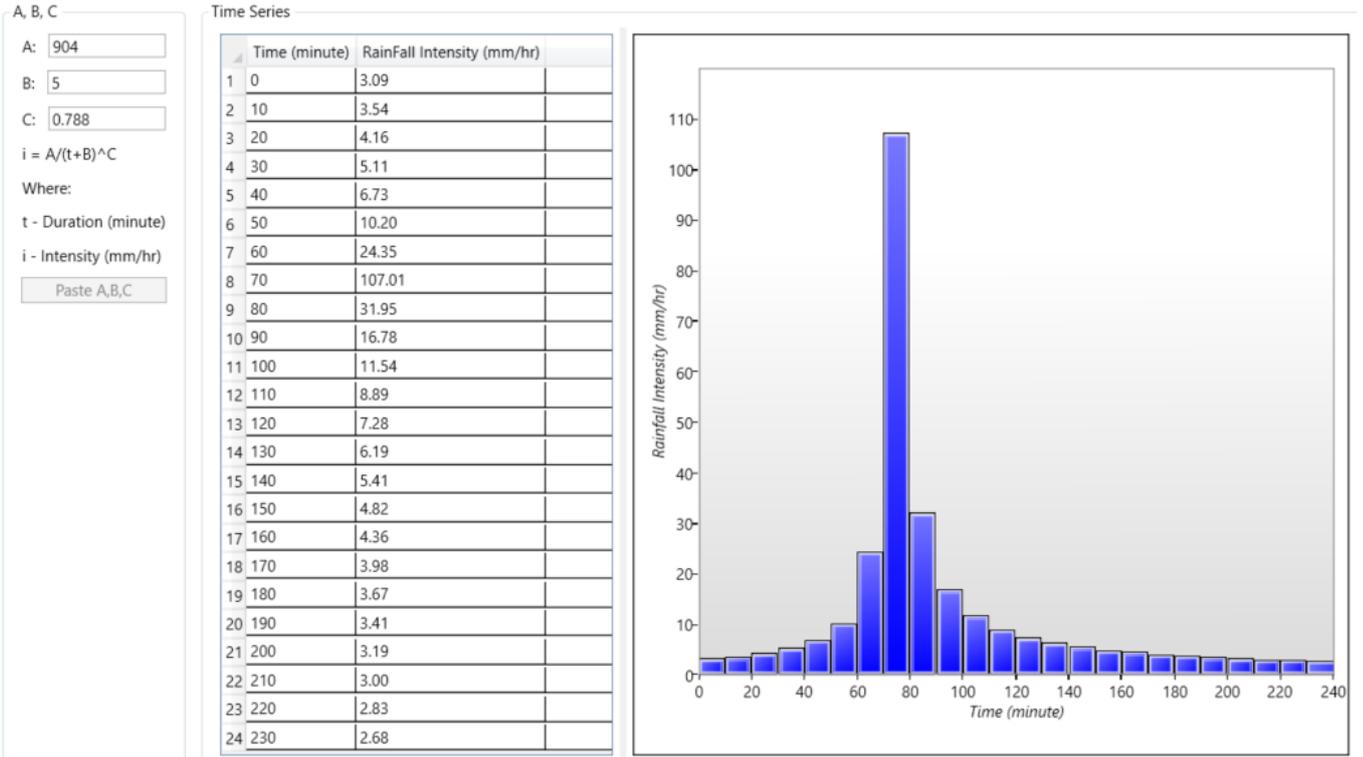
Figure C-2: 1 in 5 year hyetograph exported from Visual Otthymo

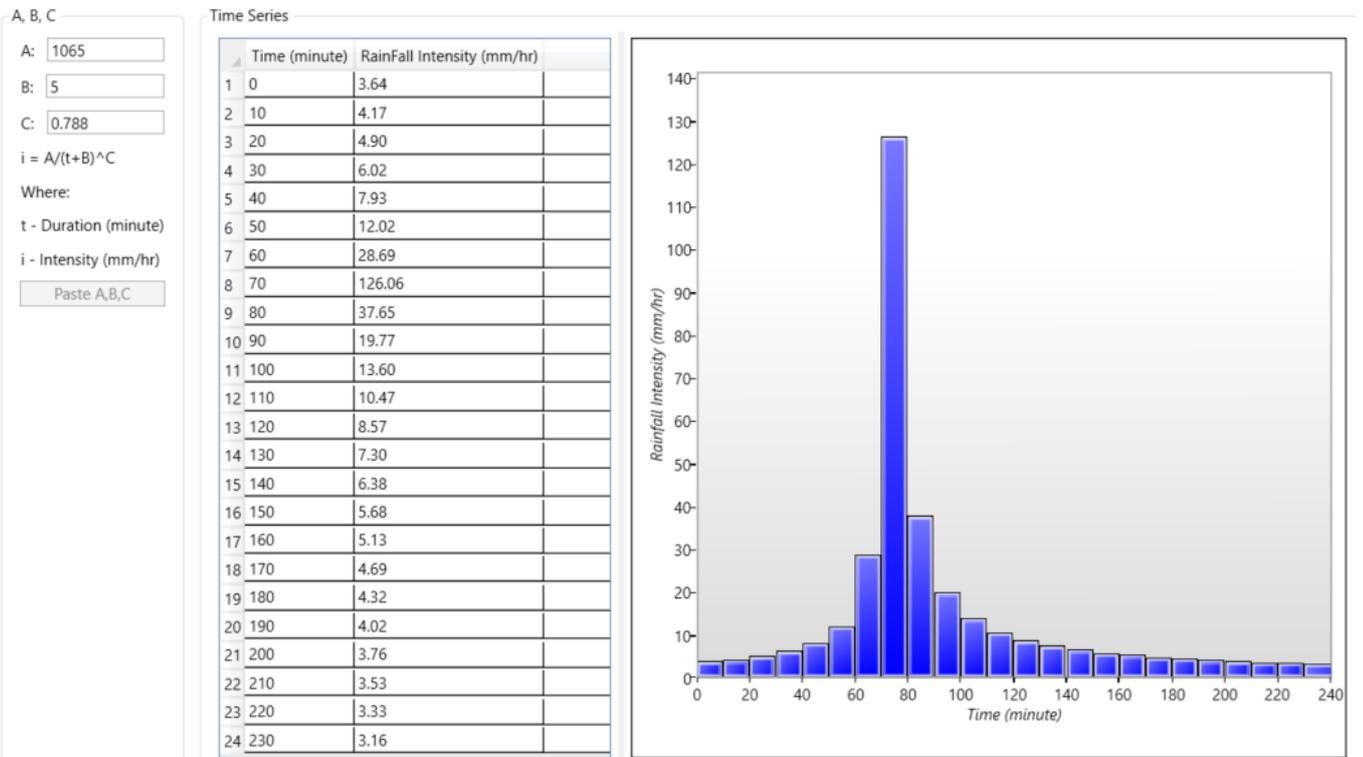
Figure C-3: 1 in 10 year hyetograph exported from Visual Otthymo

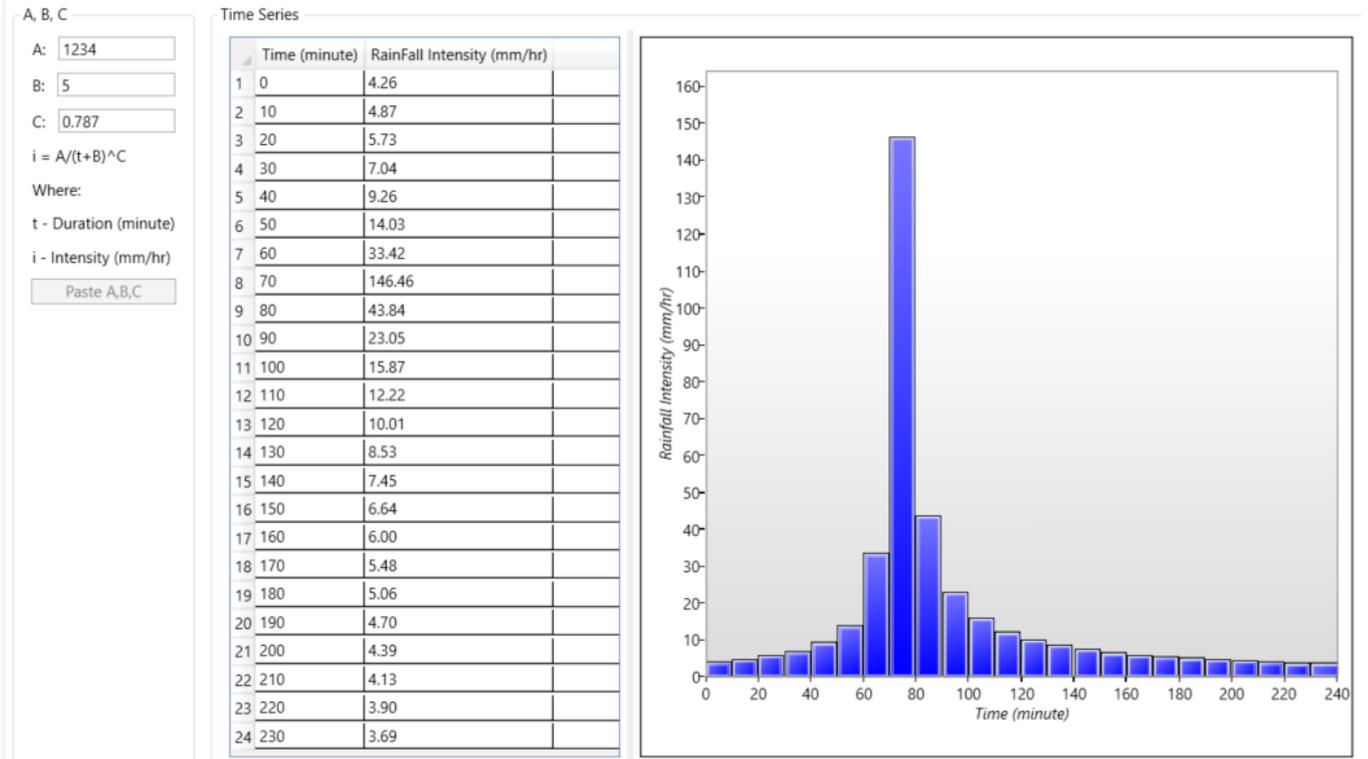
Figure C-4: 1 in 25 year hyetograph exported from Visual Otthymo

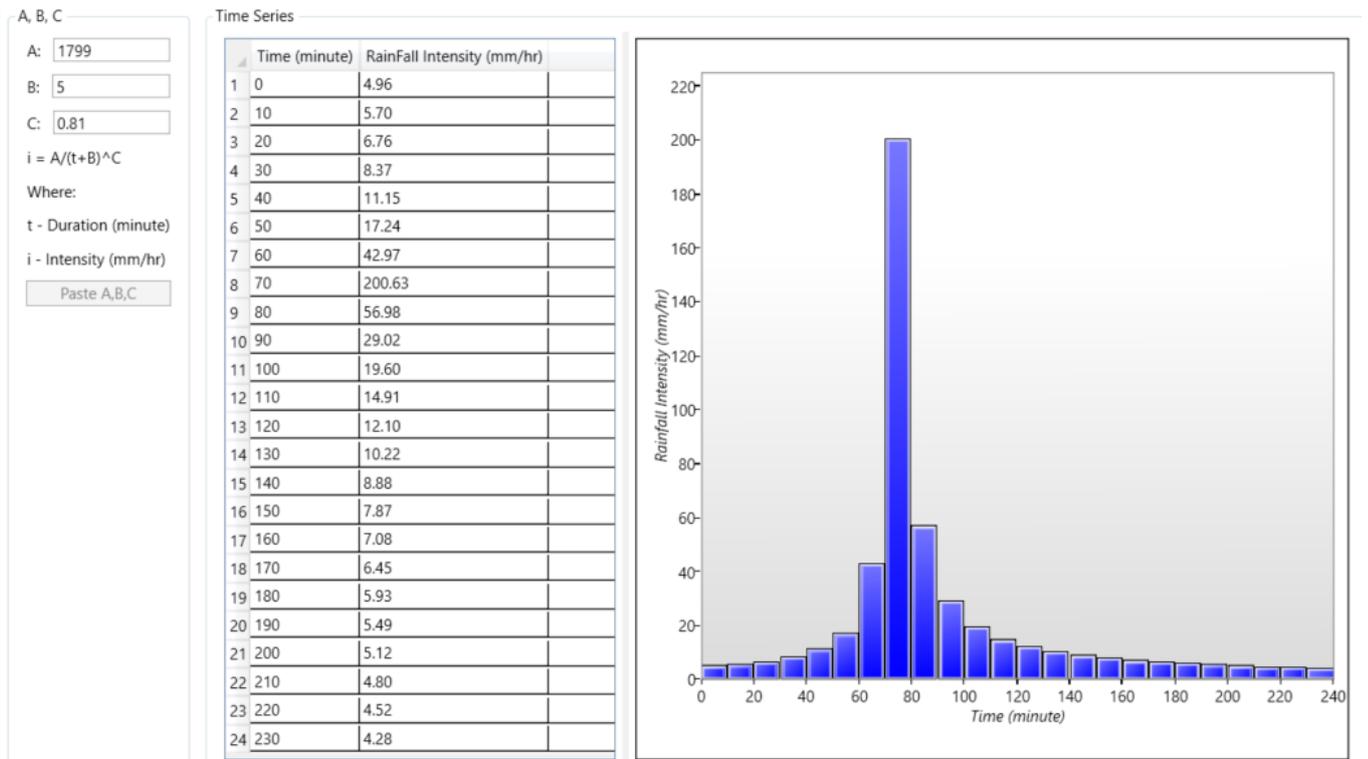
Figure C-5: 1 in 100 year hyetograph exported from Visual Otthymo

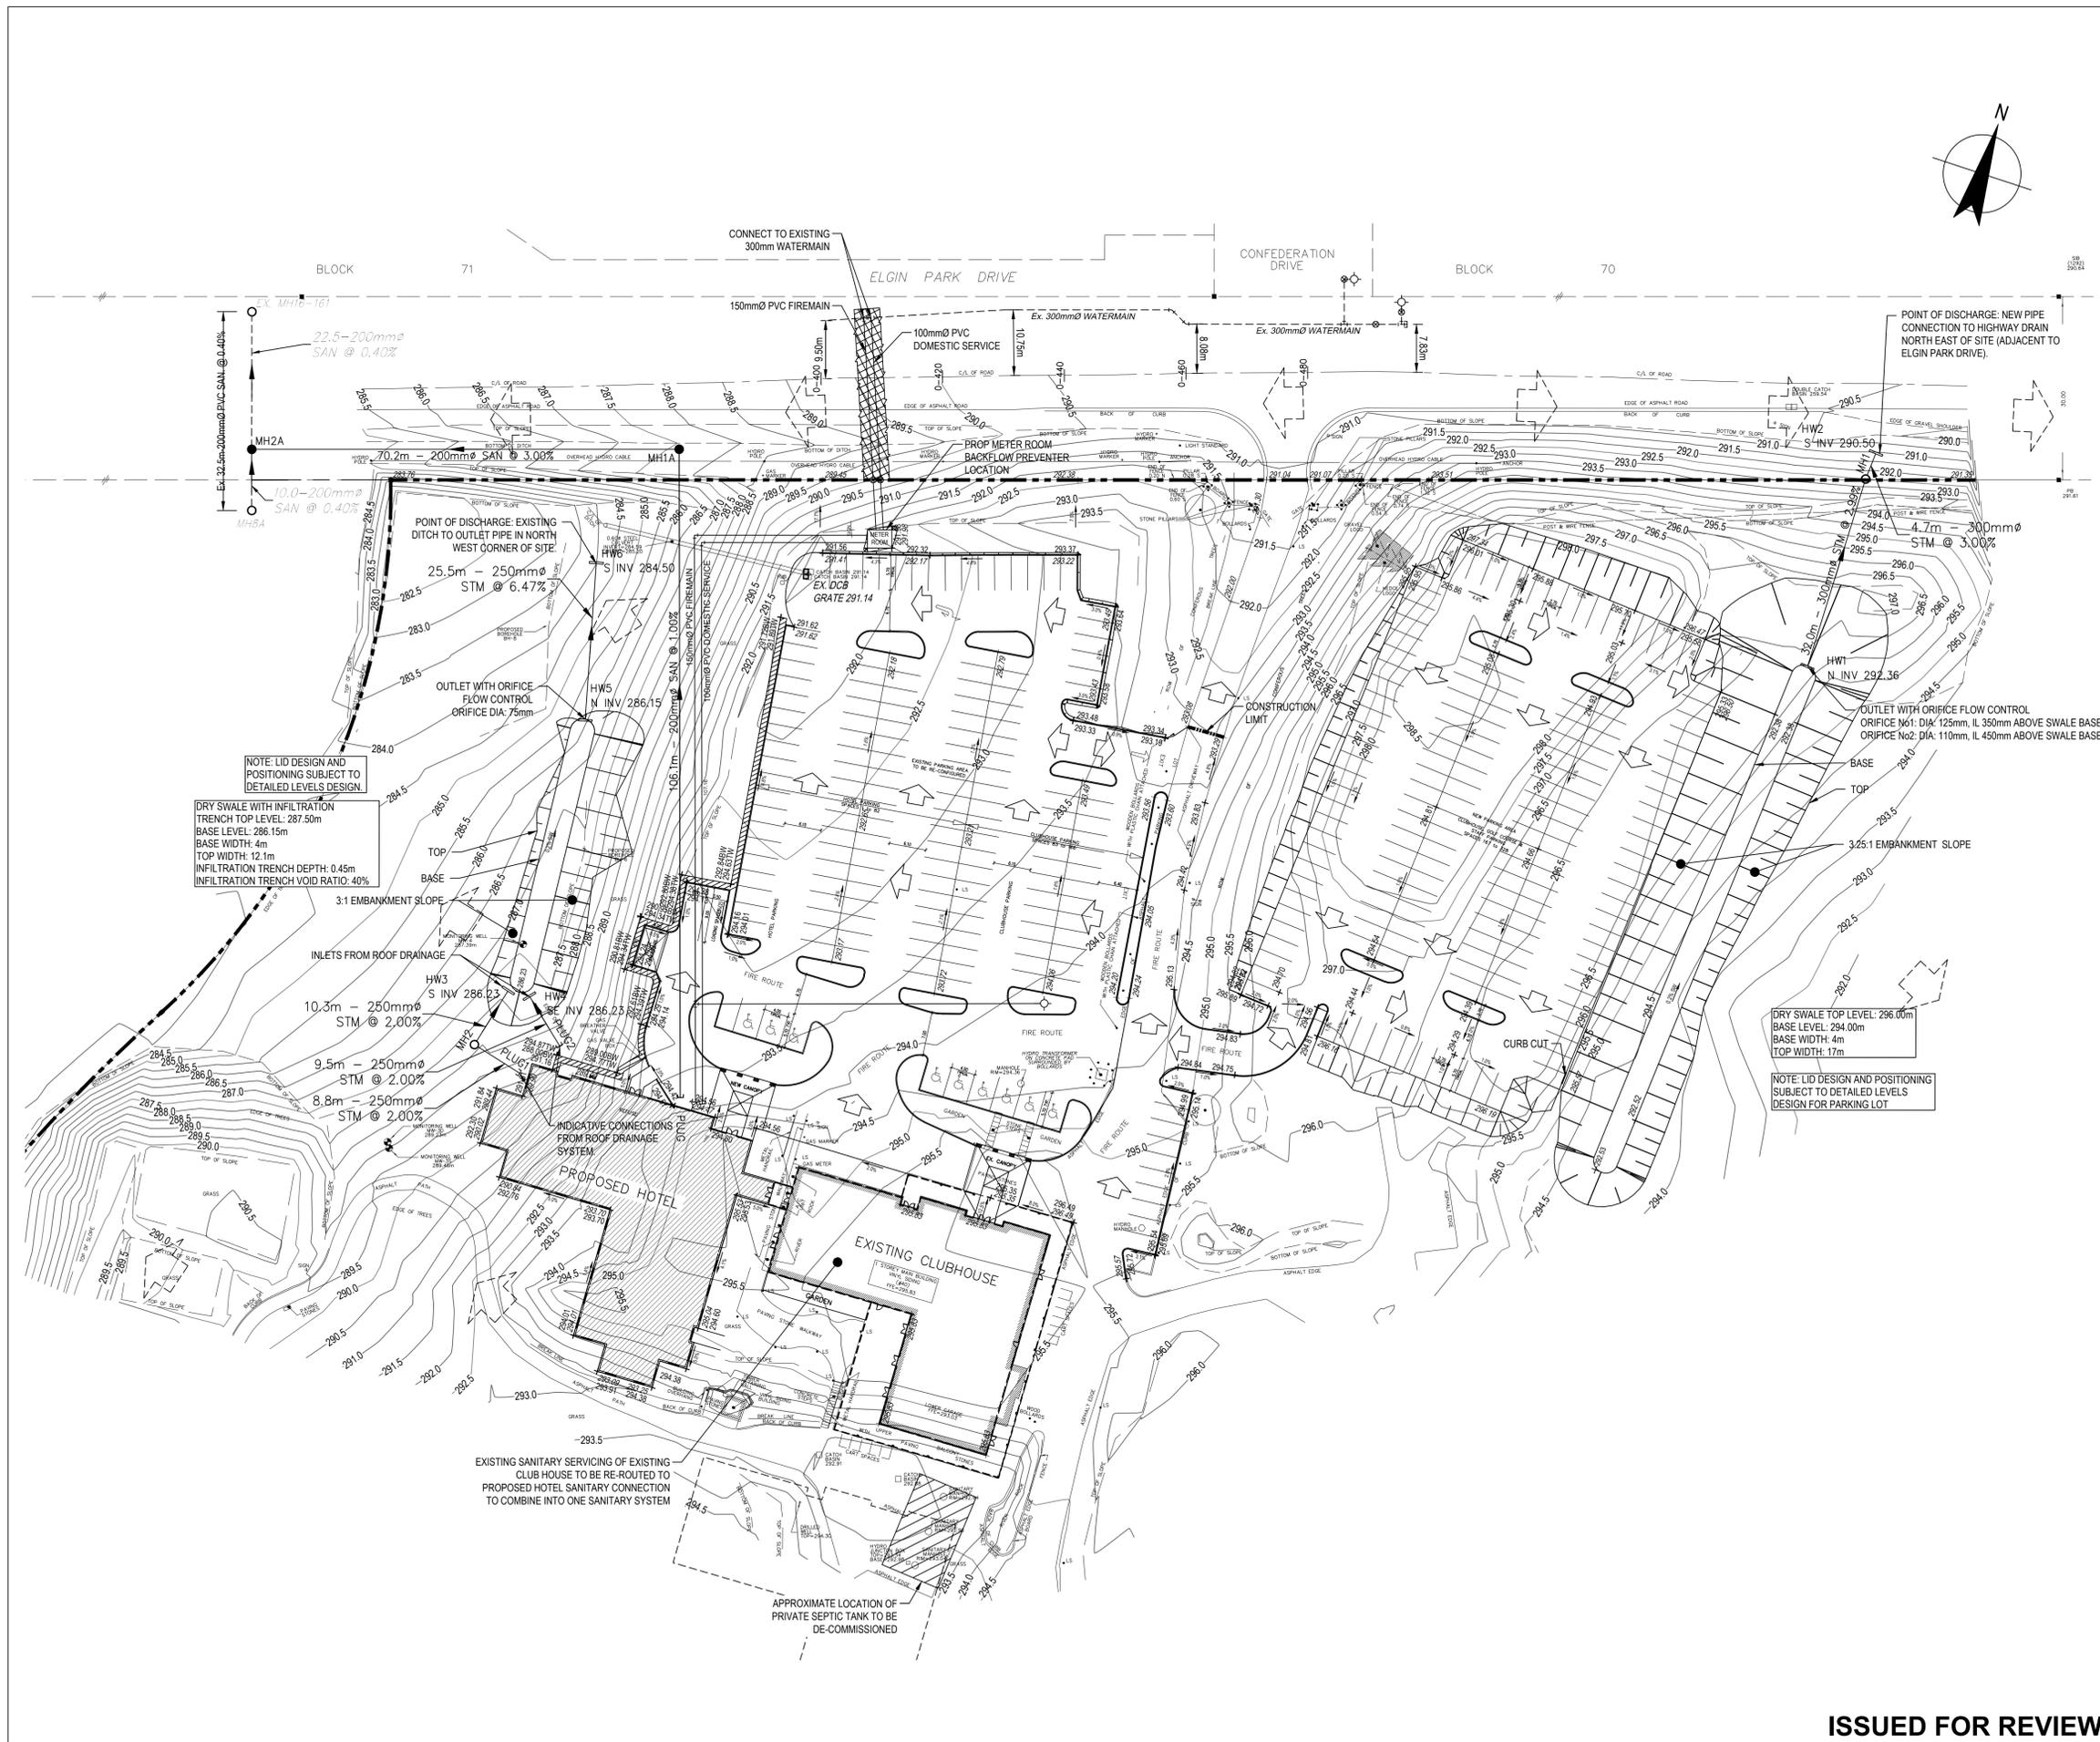
**Functional Servicing and Grading Plan
(FSGP)**
