Project Number: 240451  
27 January 2025

**Re: Summary Letter – Environmental Review  
Centennial Park – 1 Centennial Park Drive, Uxbridge, Ontario**

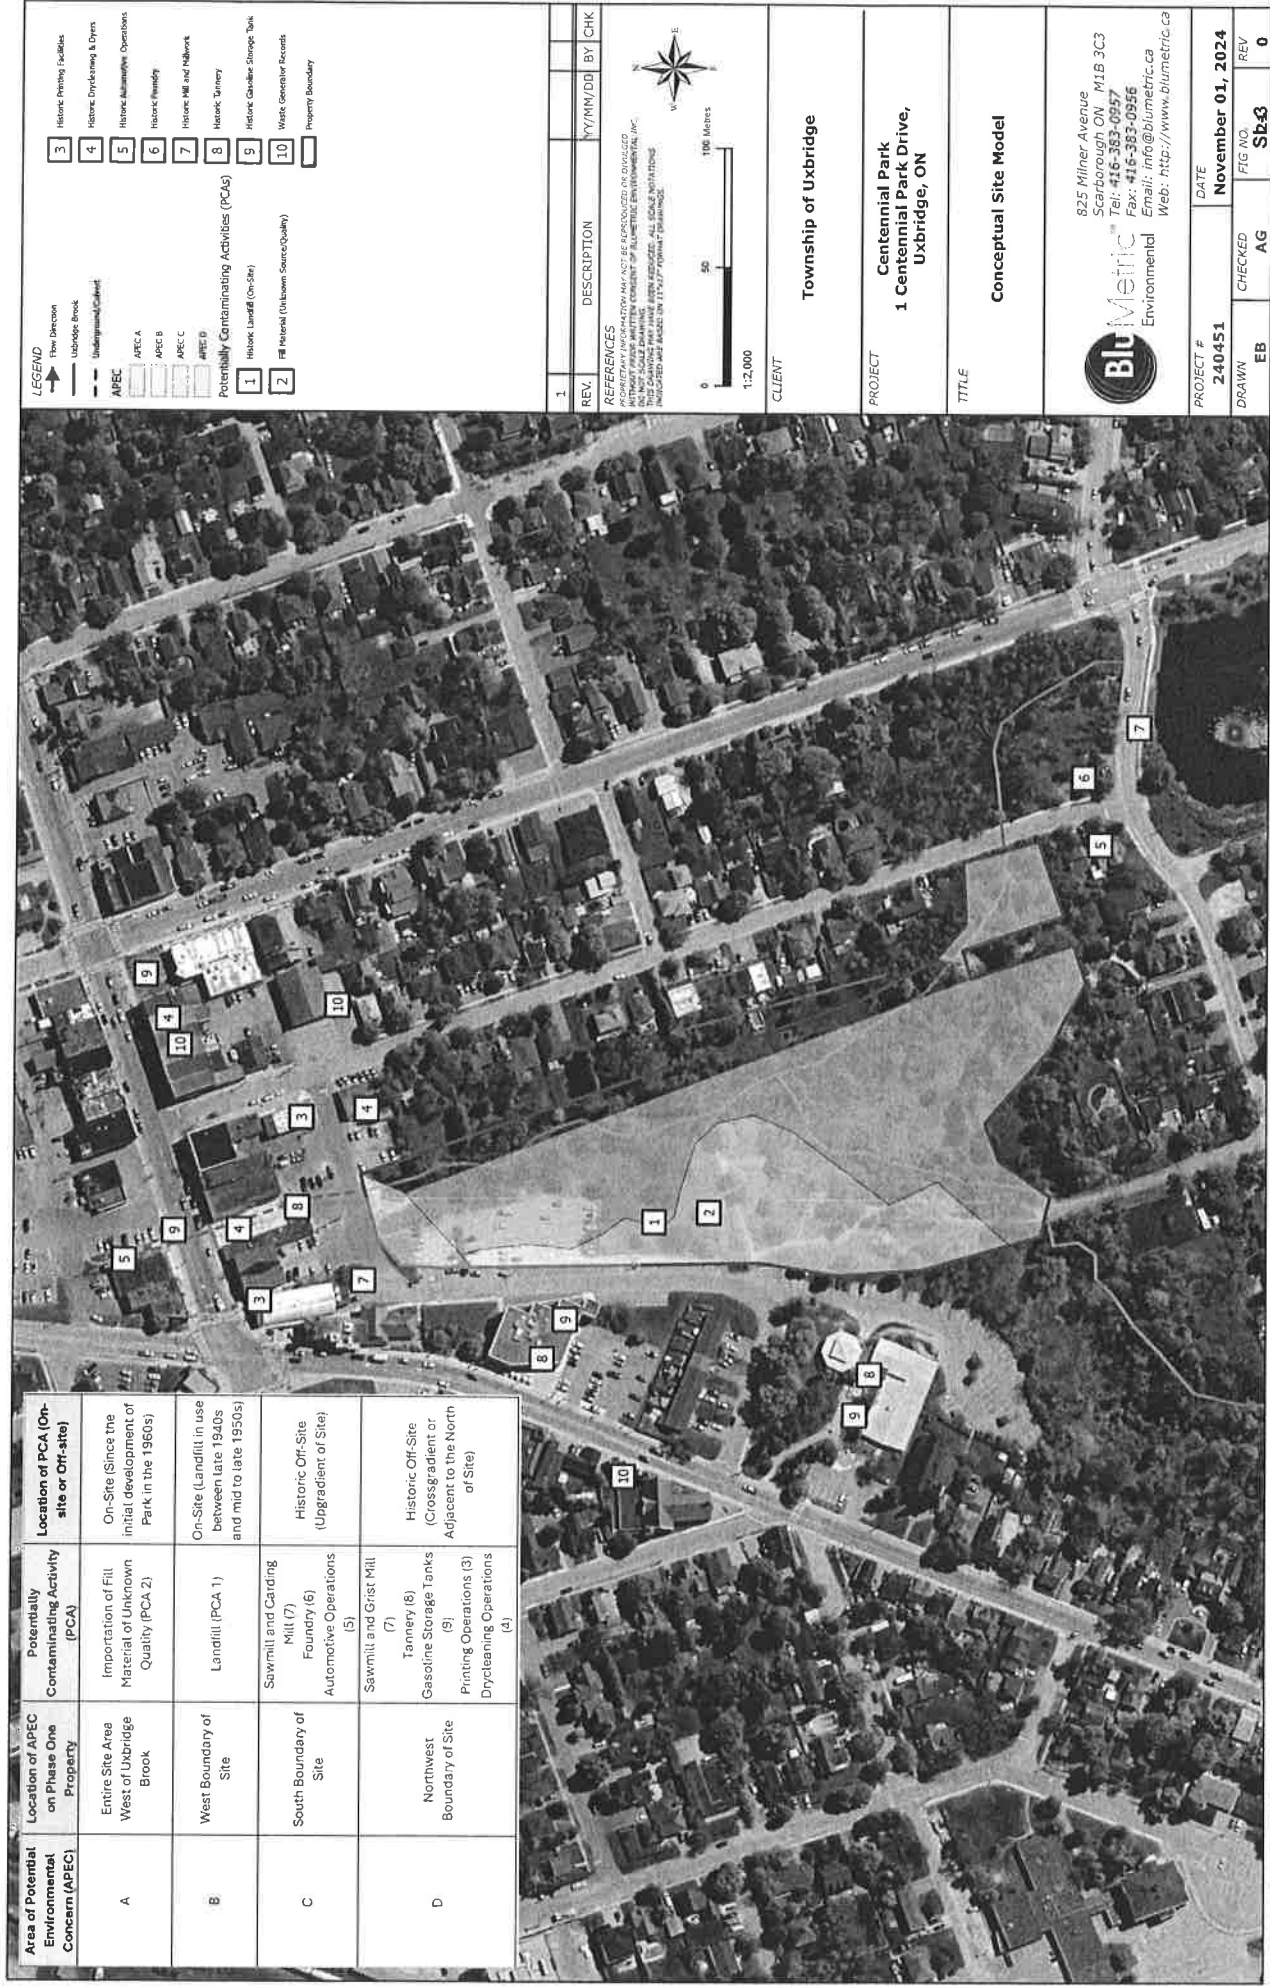
FIG NO.  
Sb-3

| Area of Potential Environmental Concern (APEC) | Location of APEC on Phase One Property | Potentially Contaminating Activity (PCA) | Location of PCA (On-site or Off-site) |
| A | Entire Site Area West of Uxbridge Brook | Importation of Fill Material of Unknown Quality (PCA 2) | On-Site (Since the initial development of Park in the 1950s) |
| B | West Boundary of Site | Landfill (PCA 1) | On-Site (Landfill in use between late 1940s and mid to late 1950s) |
| C | South Boundary of Site | Sawmill and Carding Mill (7) Foundry (6) Automotive Operations (5) | Historic Off-Site (Upgradient of Site) |
| D | Northwest Boundary of Site | Sawmill and Grist Mill (7) Tannery (8) Gasoline Storage Tanks (9) Printing Operations (3) Drycleaning Operations (4) | Historic Off-Site (Crossgradient or Adjacent to the North of Site) |

Conceptual Site Model

The above historic uses of the Site (i.e. landfill and importation of fill material) are potentially contaminating activities (PCAs) under Schedule D of Ontario Regulation 153/04 under the Environmental Protection Act (EPA). The Areas of Potential Environmental Concern (APECs) are shown on the attached Figure 21.

Based on the reviewed physical data, information, and records for Centennial Park and the surrounding properties, three areas of potential environmental concern (APECs) were identified on the Subject Property (*See Table 6 attached*). There is little available soil and ground water data on which to base an assessment of site conditions. For any proposed re-development of any area of the park, caution is recommended, and the following actions should be taken to assess the actual conditions in the proposed locations of any alteration to the park.
