**Re: Existing Drainage Conditions  
102 Prouse Road  
Lincolnville, Township of Uxbridge, Region of Durham**

Further to your comments and request, we are pleased to provide the following existing drainage report for the property located at 102 Prouse Road (former Forterra Pressure Pipe site) in the community of Lincolnville, Township of Uxbridge in the Region of Durham. This report has been prepared at the request of the Town in support of the Re-zoning application for the repurposing of the site to include an allowance for a soil remediation processing operation.

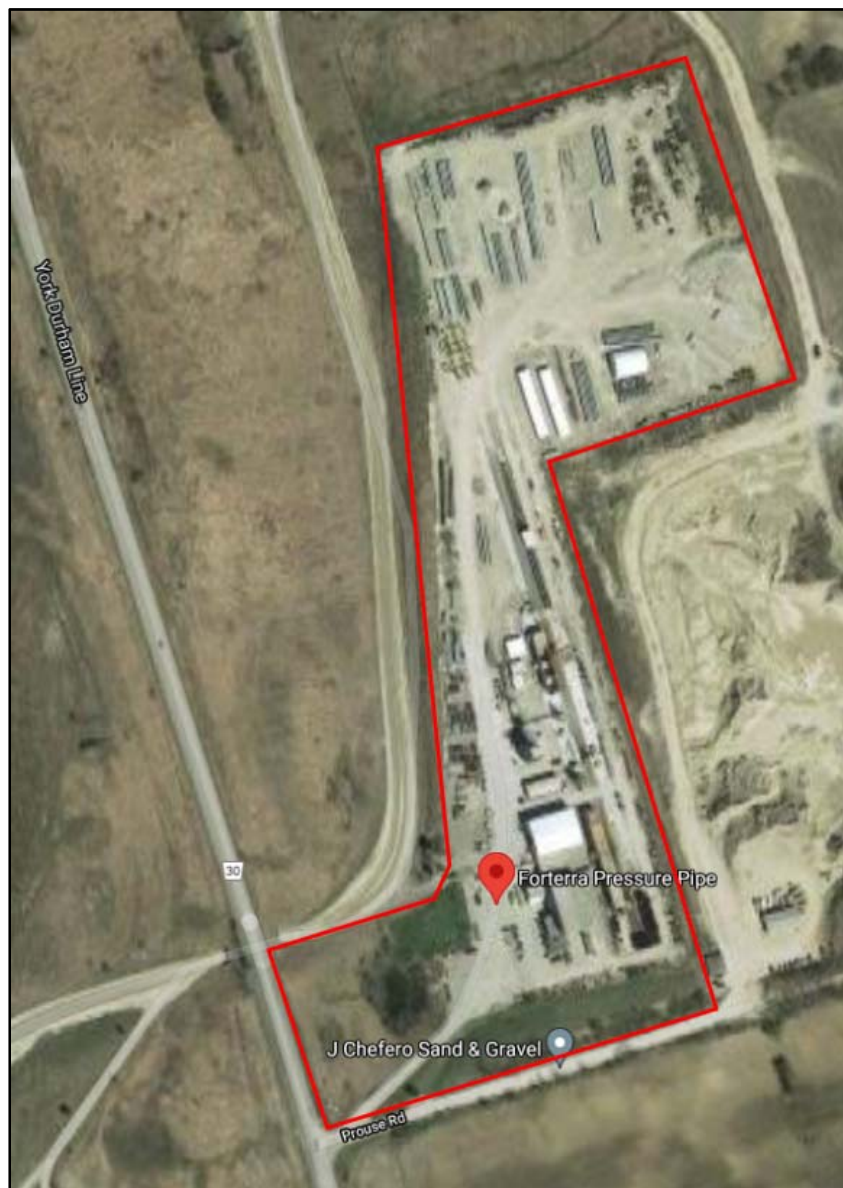
**Figure 2 – Aerial Photograph**

The site area is approximately 13.81 hectares. The adjacent land uses include aggregate pit sites with a haul road to the north, east and west of the site as well as agricultural lands south of Prouse Road. An aerial photograph of the site is shown in **Figure 2**.

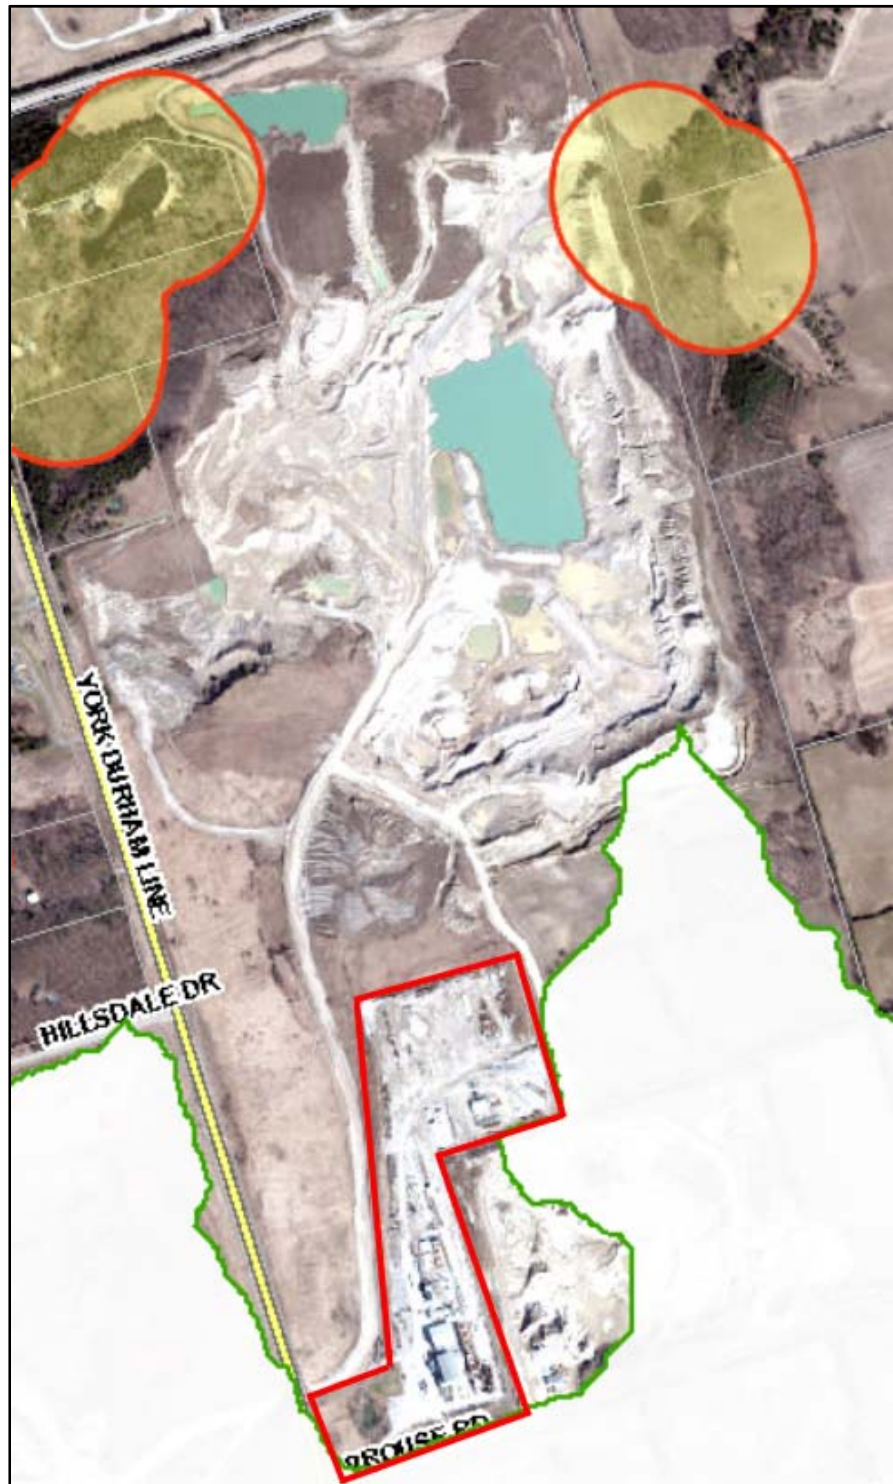
Figure 5 – LSRCA Regulated Areas (Highlighted in Yellow)

The site is not within an area regulated by Lake Simcoe Region Conservation Authority and is located at the southernmost drainage boundary of the Lake Simcoe watershed, as shown in Figure 5 below.

The Site is located within the Pefferlaw Brook subwatershed within the Lake Simcoe watershed. As shown on the LSRCA regulation mapping below in **Figure 3**, the site is on the southern edge of the Lake Simcoe drainage shed. The southern watershed boundary of Lake Simcoe along the boundary of the site is shown in greater detail in **Figure 5** by the green watershed limit boundary.
